Review

## Limestone biodeterioration: A review on the Portuguese cultural heritage scenario

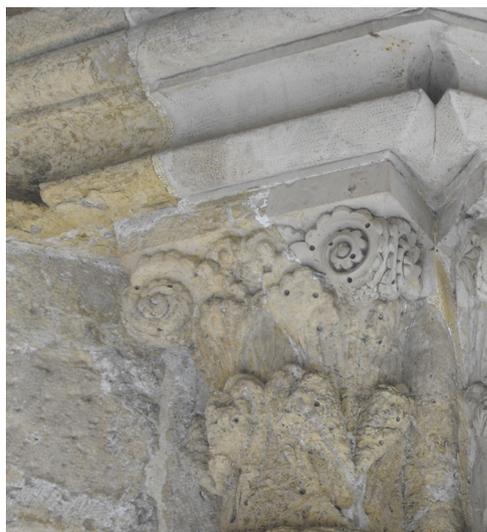
Fig. 1. Two types of limestone (yellow and white) were used for the construction and punctual rehabilitation of the Old Cathedral in Coimbra.

Dolomitic limestone (also termed dolostone) is composed of both  $\text{CaCO}_3$  and the mineral dolomite, a calcium magnesium carbonate [ $\text{CaMg}(\text{CO}_3)_2$ ] mineral. According to the proportion of magnesium and iron contents, the displayed colours can range from greyish-light brown to a yellowish tone [21,22]. A yellow toned dolomitic stone (low magnesium and high iron content) has extensively been used in the region of Coimbra [21,23] (Fig. 1).

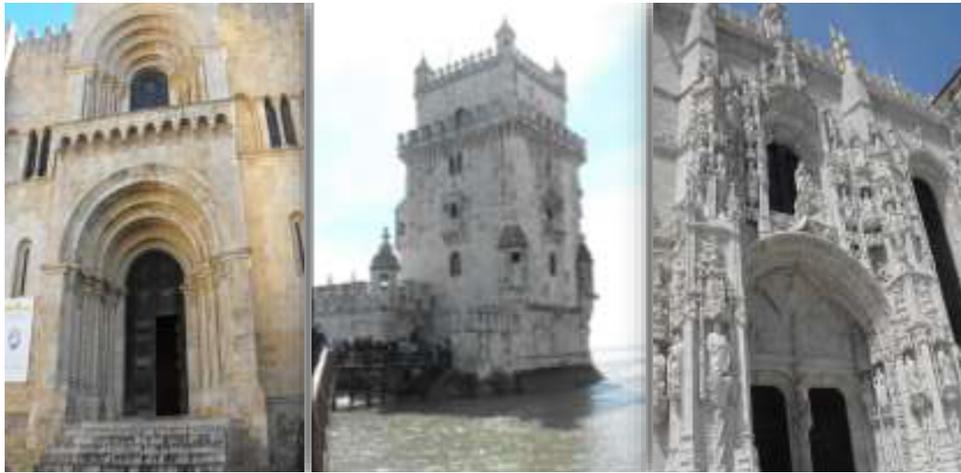
**Fig. 2.** In the Coimbra area, Ançã limestone and dolomitic limestone were frequently used. The Old Cathedral (left) displays both types. In the Lisbon area, where the Belém Tower (center) and the Jerónimos Monastery (right) are located, the Lioz limestone was used instead.

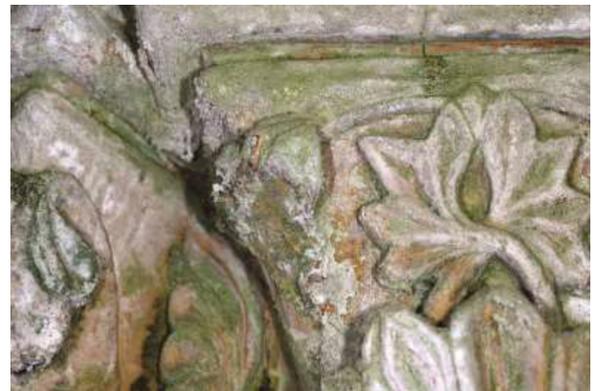
**Fig. 3.** Algae, bacteria and cyanobacteria are pioneer microorganisms which can cause significant colour alterations on stone, as displayed by the green and white shades seen above.

Besides being the most likely pioneer microorganisms and promoters of biofilm formation, algae and cyanobacteria also play a direct and important role in the physical and chemical deterioration of stone. This deterioration is characterized by the excretion of corrosive acids, especially on limestone and marble, and uptake/accumulation of sulphur, calcium and water into the cells causing cell enlargement and increased pressure on existing pores [38]. Colour alteration and the formation of black crust and patinas can also be expected [35]. Cyanobacteria also have the ability to survive under alternating cycles of drying and rehydration, and to protect themselves from UV radiation by producing protective pigments that cause colour alterations [35] (Fig. 3).

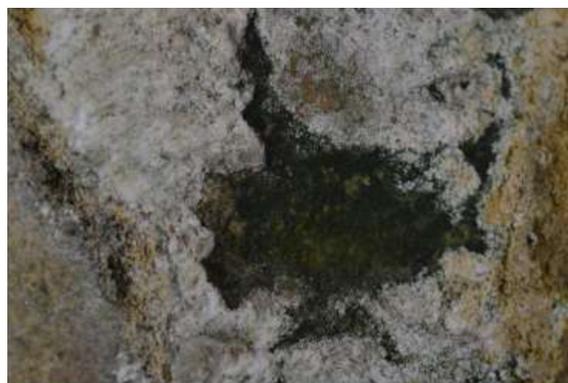
Fig. 4. Algae growing on a stone substrate where water is readily available. They form powdery or viscous layers and, as seen here, are responsible for dramatic chromatic changes.

Most studies conducted in Portugal were aimed towards algae and cyanobacteria (Table 1). Among other biodeteriorative effects, as previously mentioned, these organisms are responsible for easily noticeable green and black stains [8,34] (Fig. 4).
